LOCUST CREEK DAM  
SCHUYLKILL COUNTY, PENNSYLVANIA  
NATIONAL I.D. NO. PA 00699

⑥ PHASE I INSPECTION REPORT  
NATIONAL DAM INSPECTION PROGRAM

PHASE I INSPECTION REPORT  
NATIONAL DAM INSPECTION PROGRAM  
LOCUST CREEK DAM  
(TUSCARORA STATE PARK DAM)  
NATIONAL ID NO. PA 00699  
DER NO. 54-170

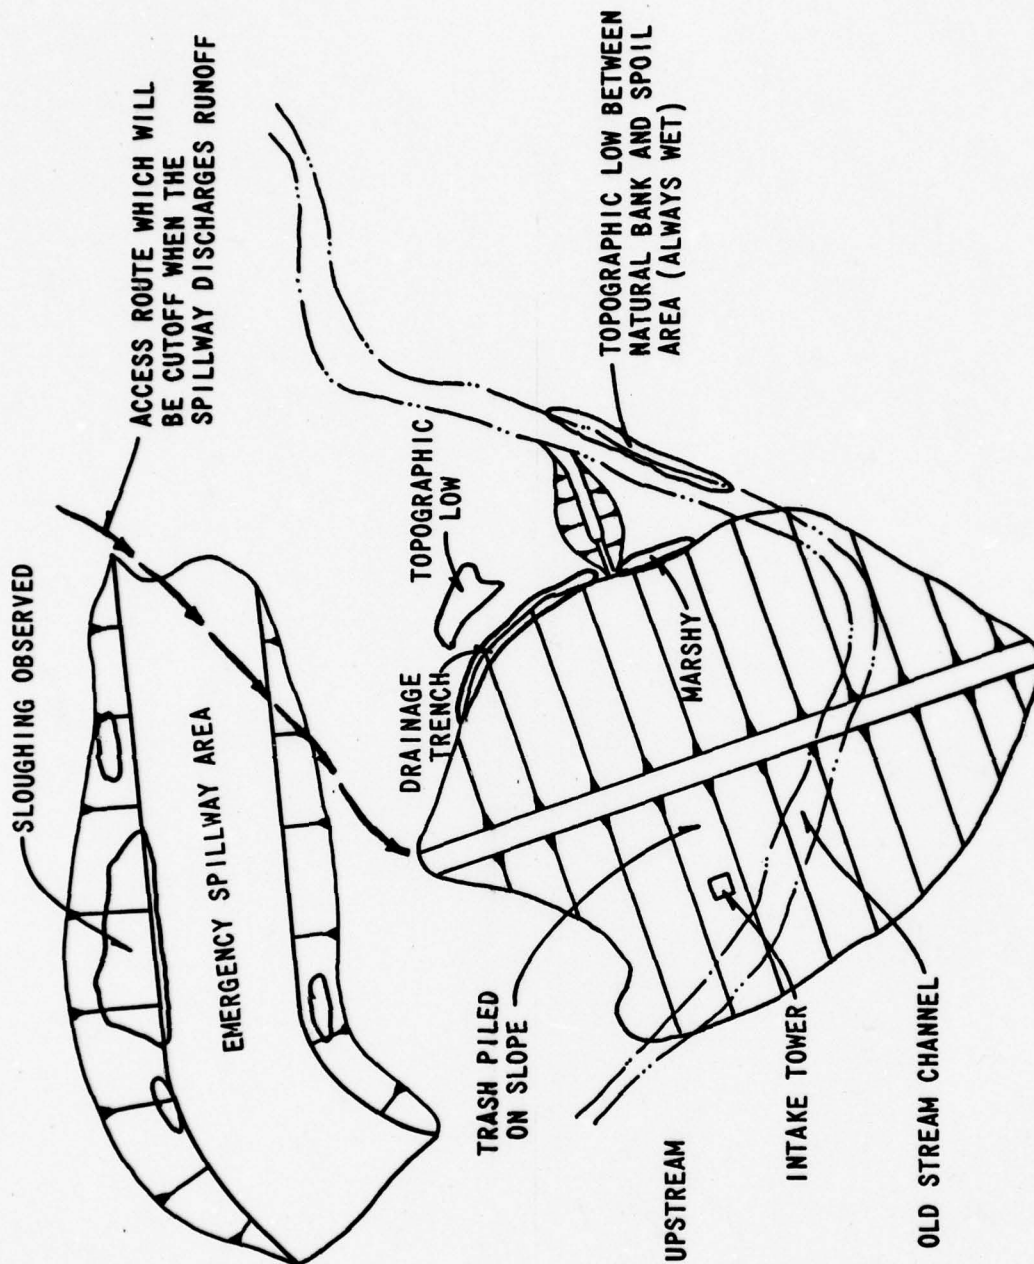
SEEPAGE LOCATION PLAN AND  
NOTES FROM FIELD INSPECTION  
TUSCARORA STATE PARK DAM

A careful inspection of the marshy areas located as shown on Sheet 5a of Appendix B reveal that these zones were topographic lows which temporarily retain run-off water. Inspection reports located in DER files further confirm that the topographic lows were created during the construction of the dam and during repair work to the discharge conduit.

*See Sheet 5a. Cattails were noted along the toe of the dam right of the discharge plung pool. Other areas of standing water were observed as noted on the sketch.*

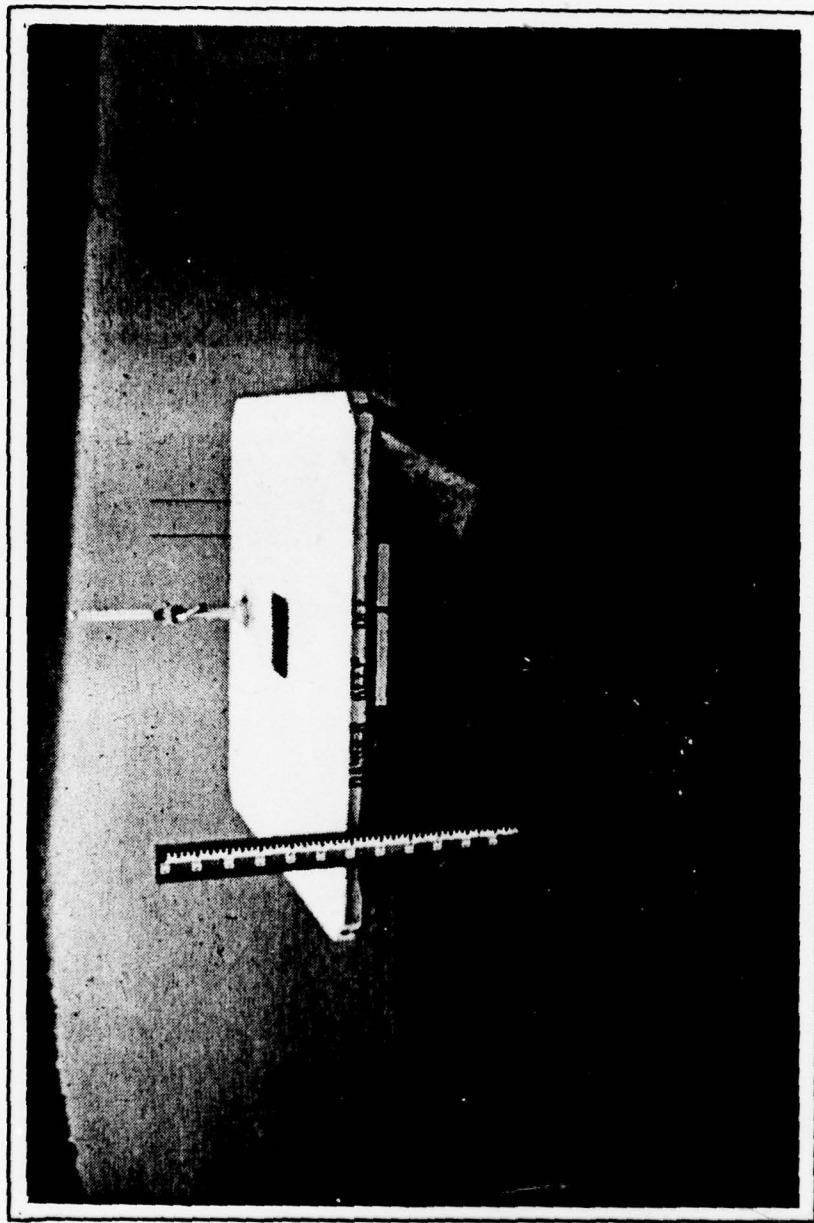
PINCIPAL SPILLWAY. NOTE POND  
DRAIN VALVE AND STAFF GAGE.

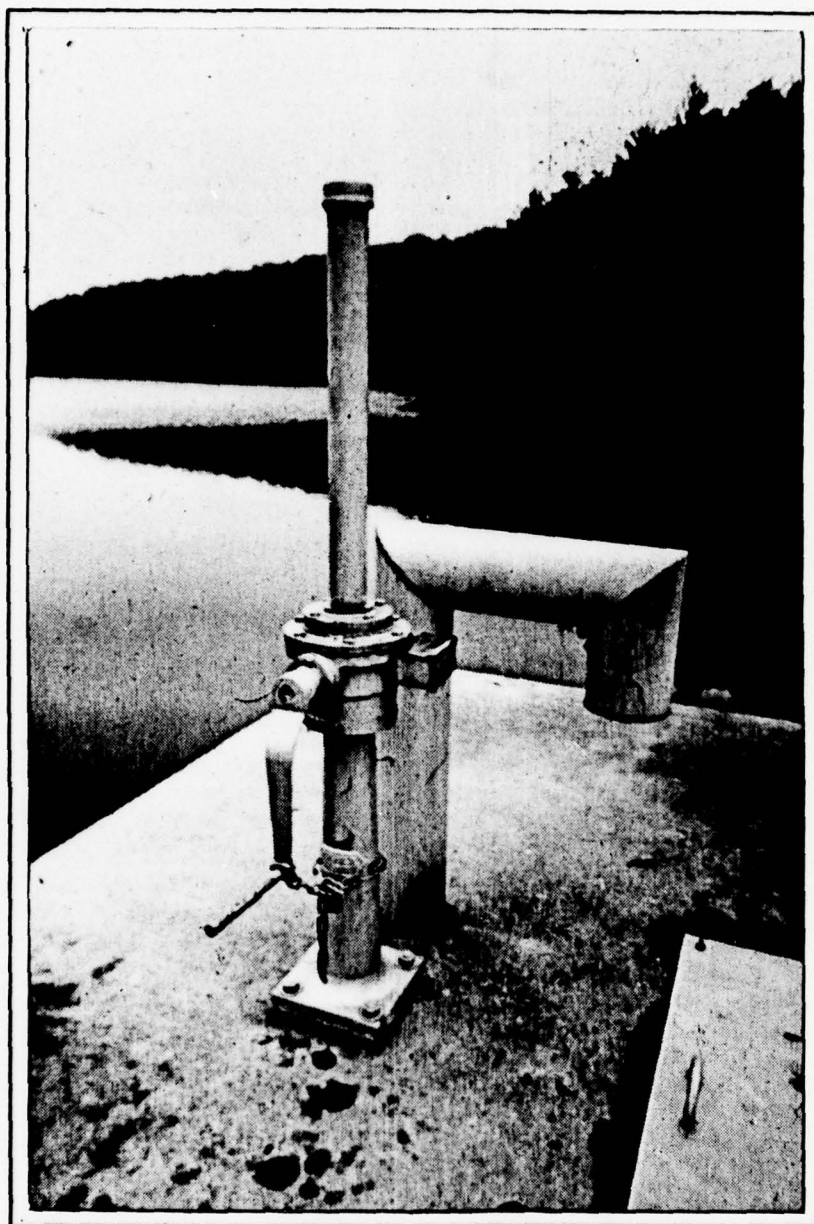
PHOTOGRAPH NO. 2

CLOSEUP VIEW OF POND DRAIN  
AND AIR VENT.

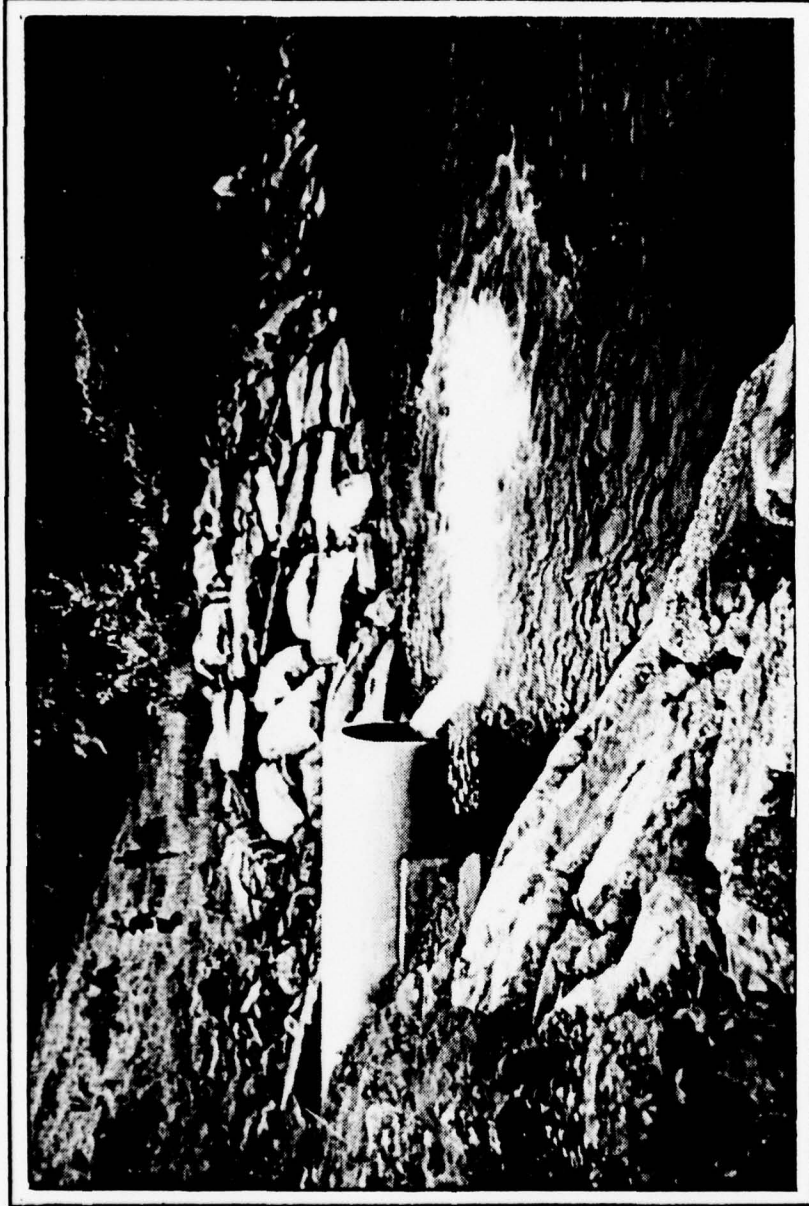
PHOTOGRAPH NO. 4

The discharge pipe could not be inspected because of water flowing over the principal spillway. It is noted that representatives from the Department of Environmental Resources (DER) periodically inspect this pipe.

PRINCIPAL SPILLWAY DISCHARGE  
PIPE.

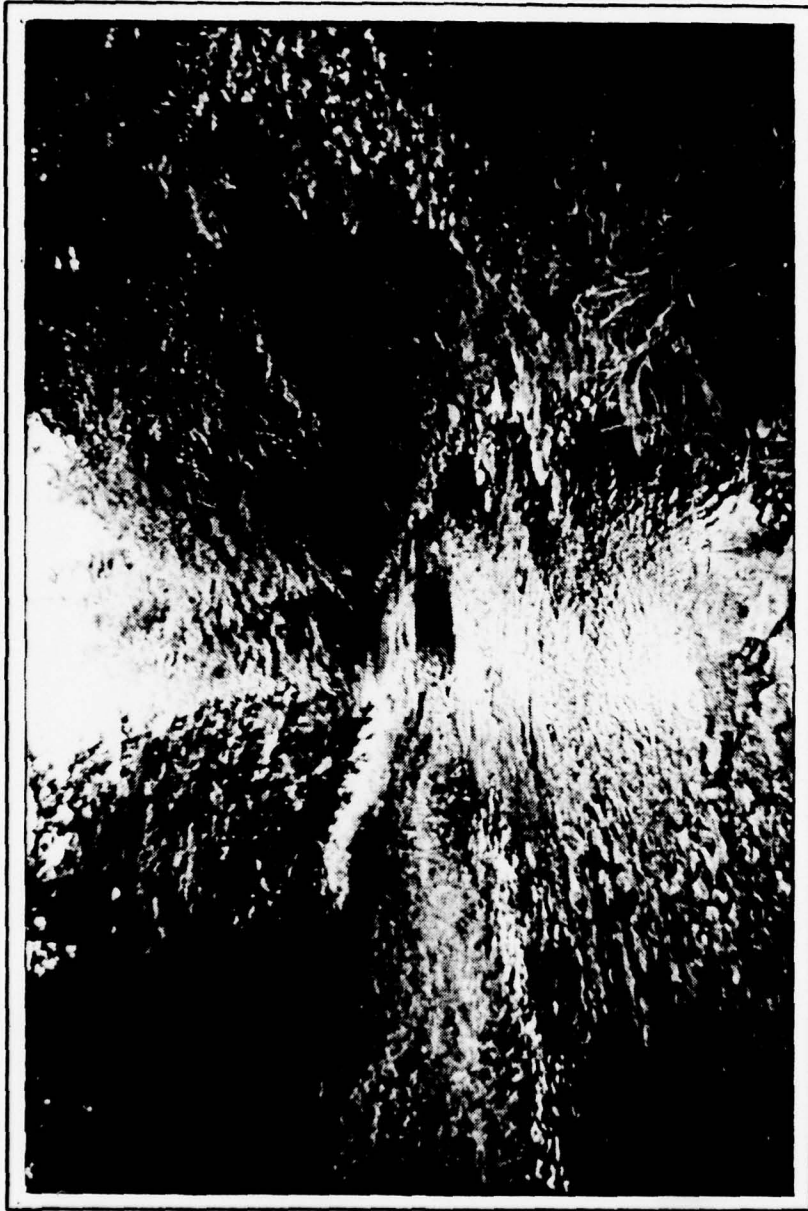
PHOTOGRAPH NO. 5

The plunge pool was inspected and found to be in good condition. Some riprap movement was observed as was observed by DER during previous inspections. The toe drain discharge pipes are below the plunge pool water level and could not be inspected. The riprap-lined discharge channel between the plunge pool and the natural stream bed was inspected and found to be quite stable and in good condition.

VIEW OF DOWNSTREAM CHANNEL  
BELOW PRINCIPAL SPILLWAY  
STILLING BASIN.

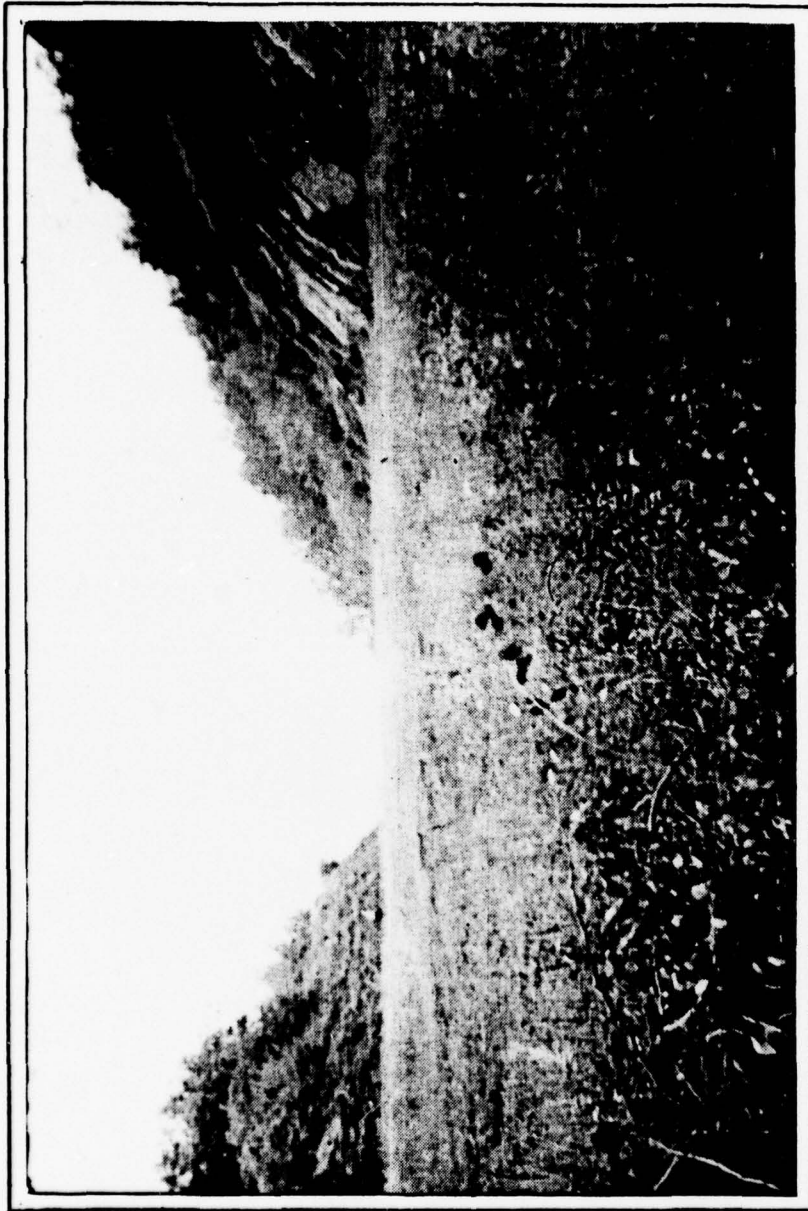
PHOTOGRAPH NO. 6

The emergency spillway located left of the embankment was inspected and observed to be in good condition. Scars from previous slides principally along the left wall of the channel were observed. Some minor accumulations of rock talus were observed along the base of both sides of the channel. Surface degradation of the rock is also evident. Some vegetation is beginning to grow in the crevices and will further degrade these materials. It is not expected that this degradation will significantly affect the performance of the spillway within the near future. However, additional slope sloughing should be expected during the life of this structure. The drop-off at the end of the emergency spillway was inspected and some recent cutting of trees was observed. The channel bottom is fairly stable and in good condition.

EMERGENCY SPILLWAY LOOKING  
UPSTREAM.

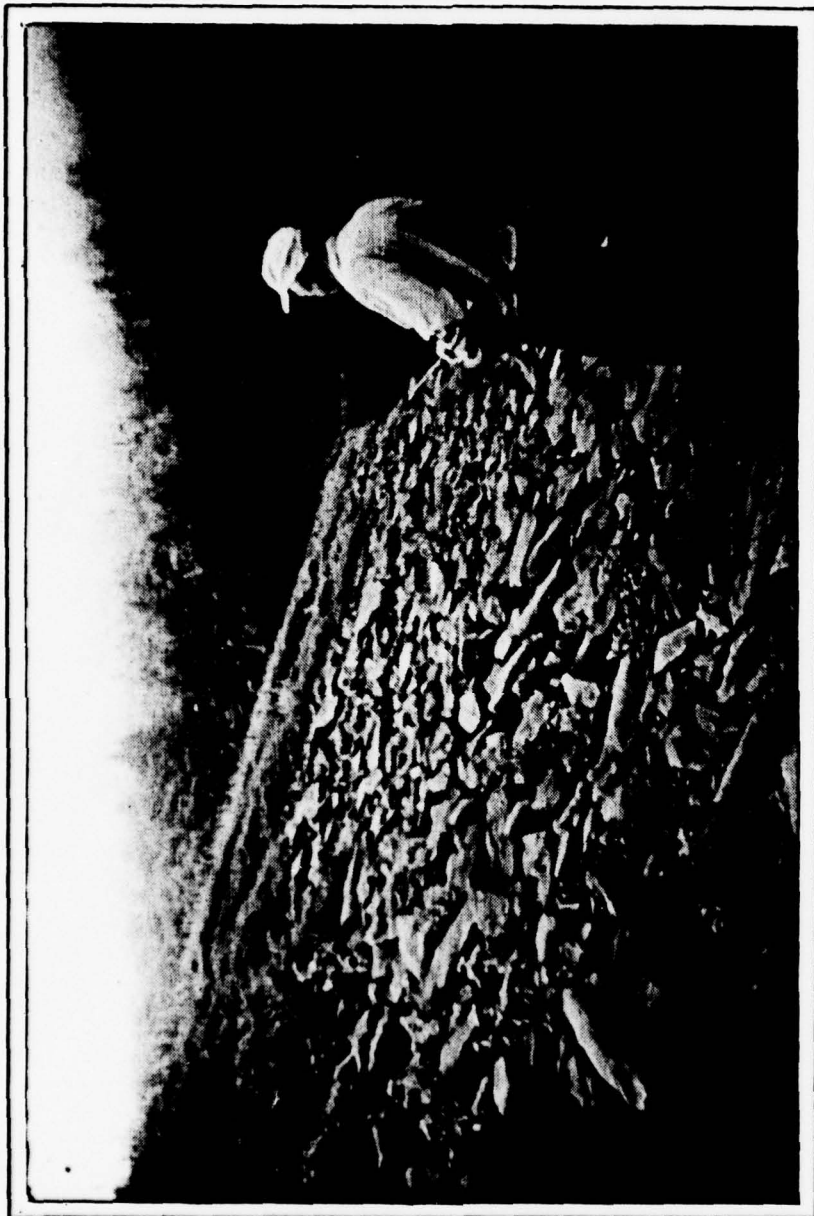
PHOTOGRAPH NO. 9

There were no signs of riprap distortion, movement, or deterioration. The quality of the rock is good; however, the rock is principally composed of shale materials which are expected to weather and decompose over the years. Signs of decomposition in the form of slaking and crumbling are already in evidence.

UPSTREAM RIPRAP SLOPE RIGHT  
OF PRINCIPAL SPILLWAY.

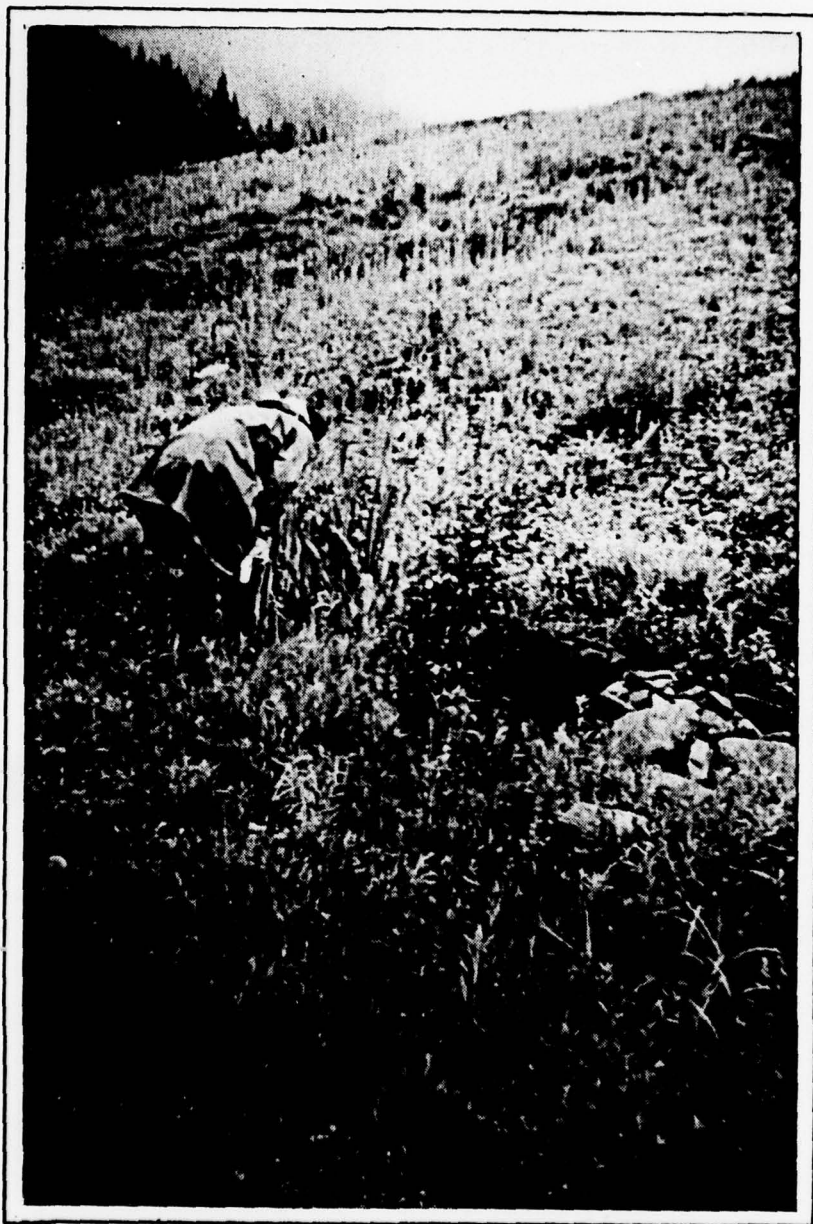
SEEPAGE AT DOWNSTREAM TOE  
TO THE RIGHT OF THE OUTLET  
PIPE. SEE SHEET 5a OF  
APPENDIX B. CATTAILS  
DELINEATE AREA.

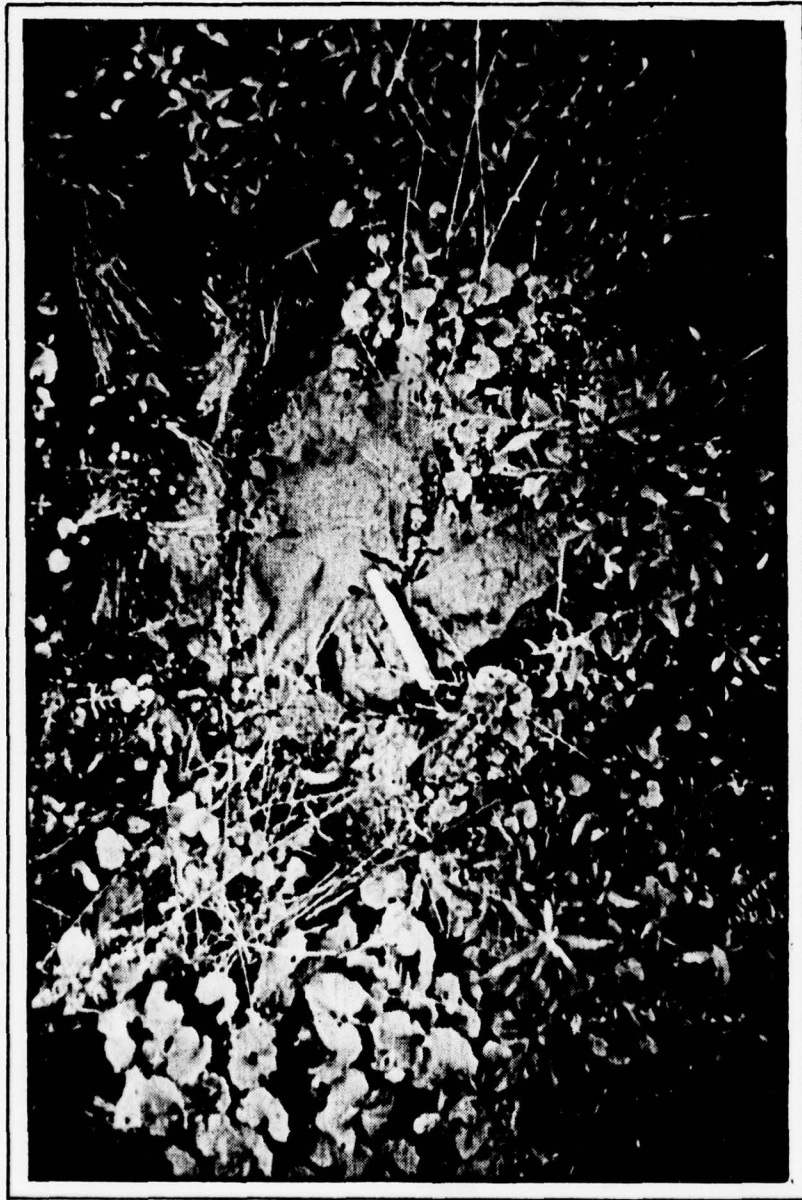
PHOTOGRAPH NO. 14

SEEPAGE WATER AT DOWNSTREAM  
TOE RIGHT OF OUTLET PIPE.

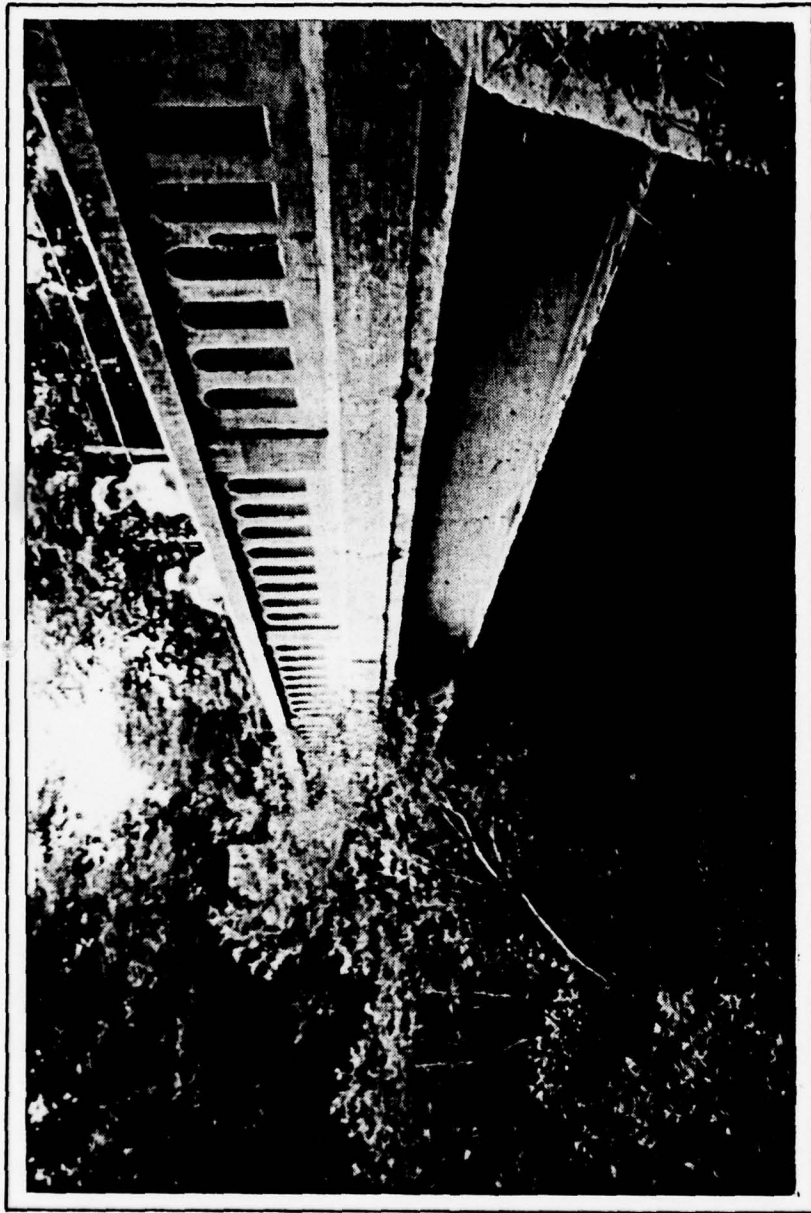
PHOTOGRAPH NO. 15

f. Downstream Conditions. Approximately 3,700 feet downstream of the dam, Locust Creek joins the Little Schuylkill River. Immediately upstream of the confluence, a highway bridge crosses Locust Creek, which is subject to flooding. The bridge is expected to flood at discharges of between 5,400 cfs and 9,100 cfs, depending on the water surface elevation in Little Schuylkill River.

VIEW OF ONLY BRIDGE DOWNSTREAM  
OF DAM.
